APPENDIX E

Interview Documentation

RECORD OF COMMUNICATION						
Site Name: Burgess Mill			Location (city): Berlin, New Hampshire			
Communications with: Fred McGarry, P.E., NHDES - Waste Management Division						
Location: Concord, New Hampshire			Phone: (603)271-3503			
Communication via		Telephone		Letter	<input checked="" type="checkbox"/>	In Person
Recorded By: B. Smith			Of: H & A			
At: (time): 0800 - 0830			On (date): 19 February 2002			
Re: Primary NHDES concerns re: site						
<p>Summary of Communication: Reviewed Cell House status, received draft sediment sampling results for mercury (by R.F. Weston, samples collected 2-4 December 2001). Fish tissue sampling results reportedly relatively low. Low levels (~AGQS) of mercury in discharge from Cell House area. Wastewater sludge from Burgess Plant not likely an issue for disposal due to large amounts of "clean" process water (18 - 20 mgd). Additional investigation at Cell House area likely required. Likely sludge went to Dummer or Mt. Carberry landfills.</p> <p>T-1 Transformer Area contains elevated PCBs in soil and groundwater. Request in from NHDES to EPA for NHDES to take enforcement lead, based on groundwater impacts.</

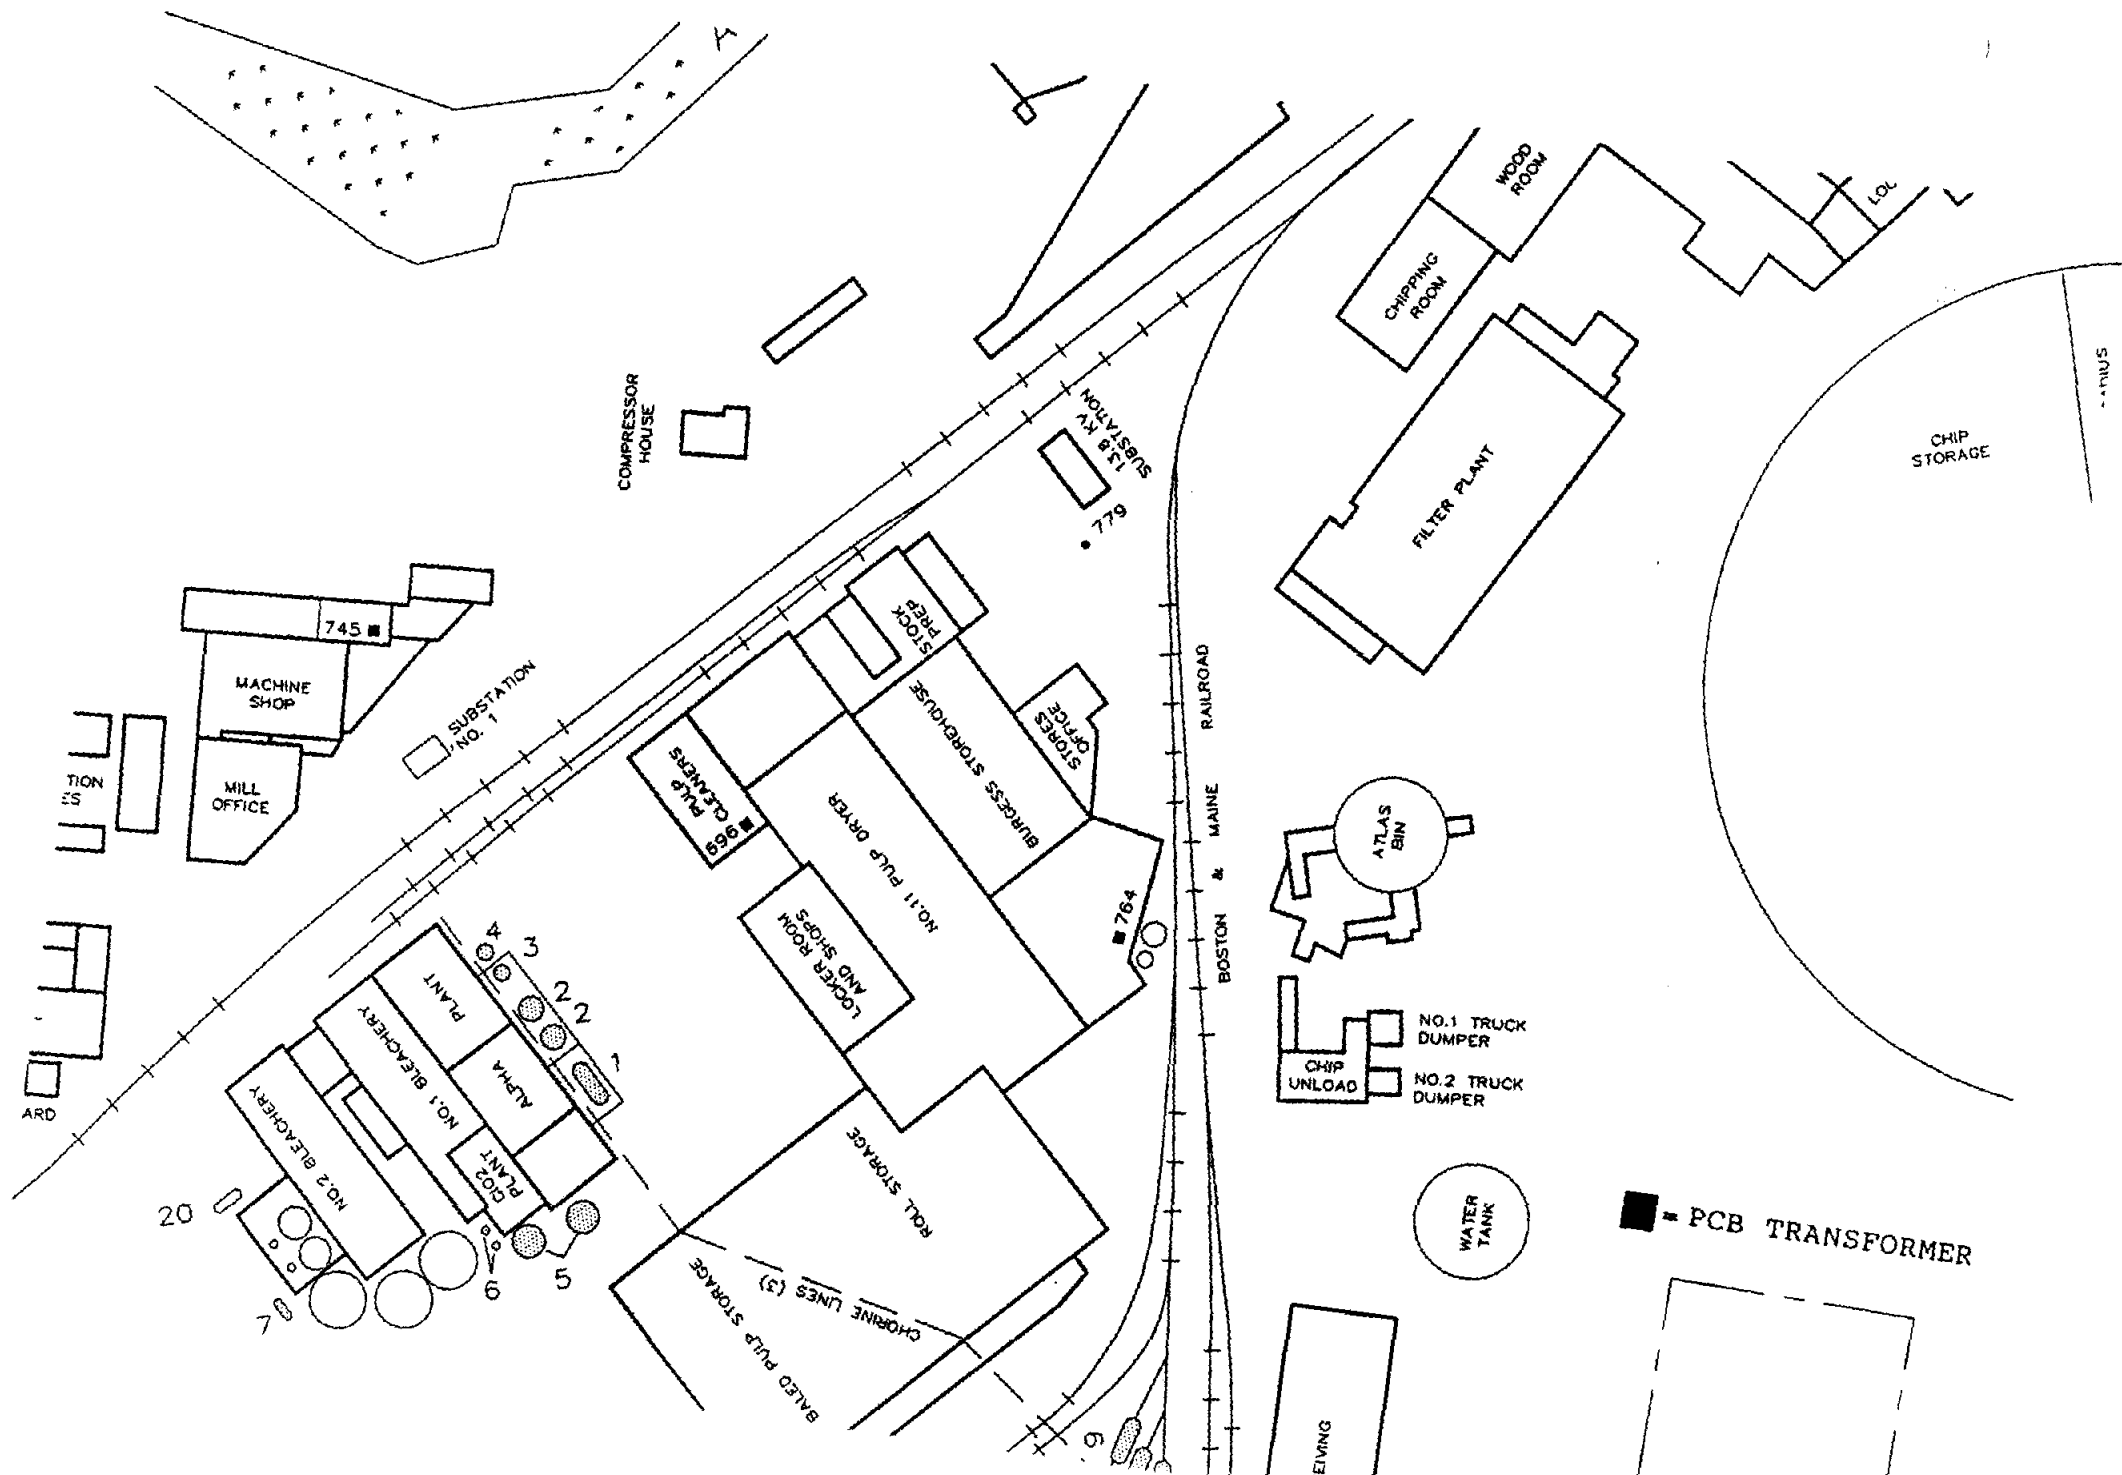
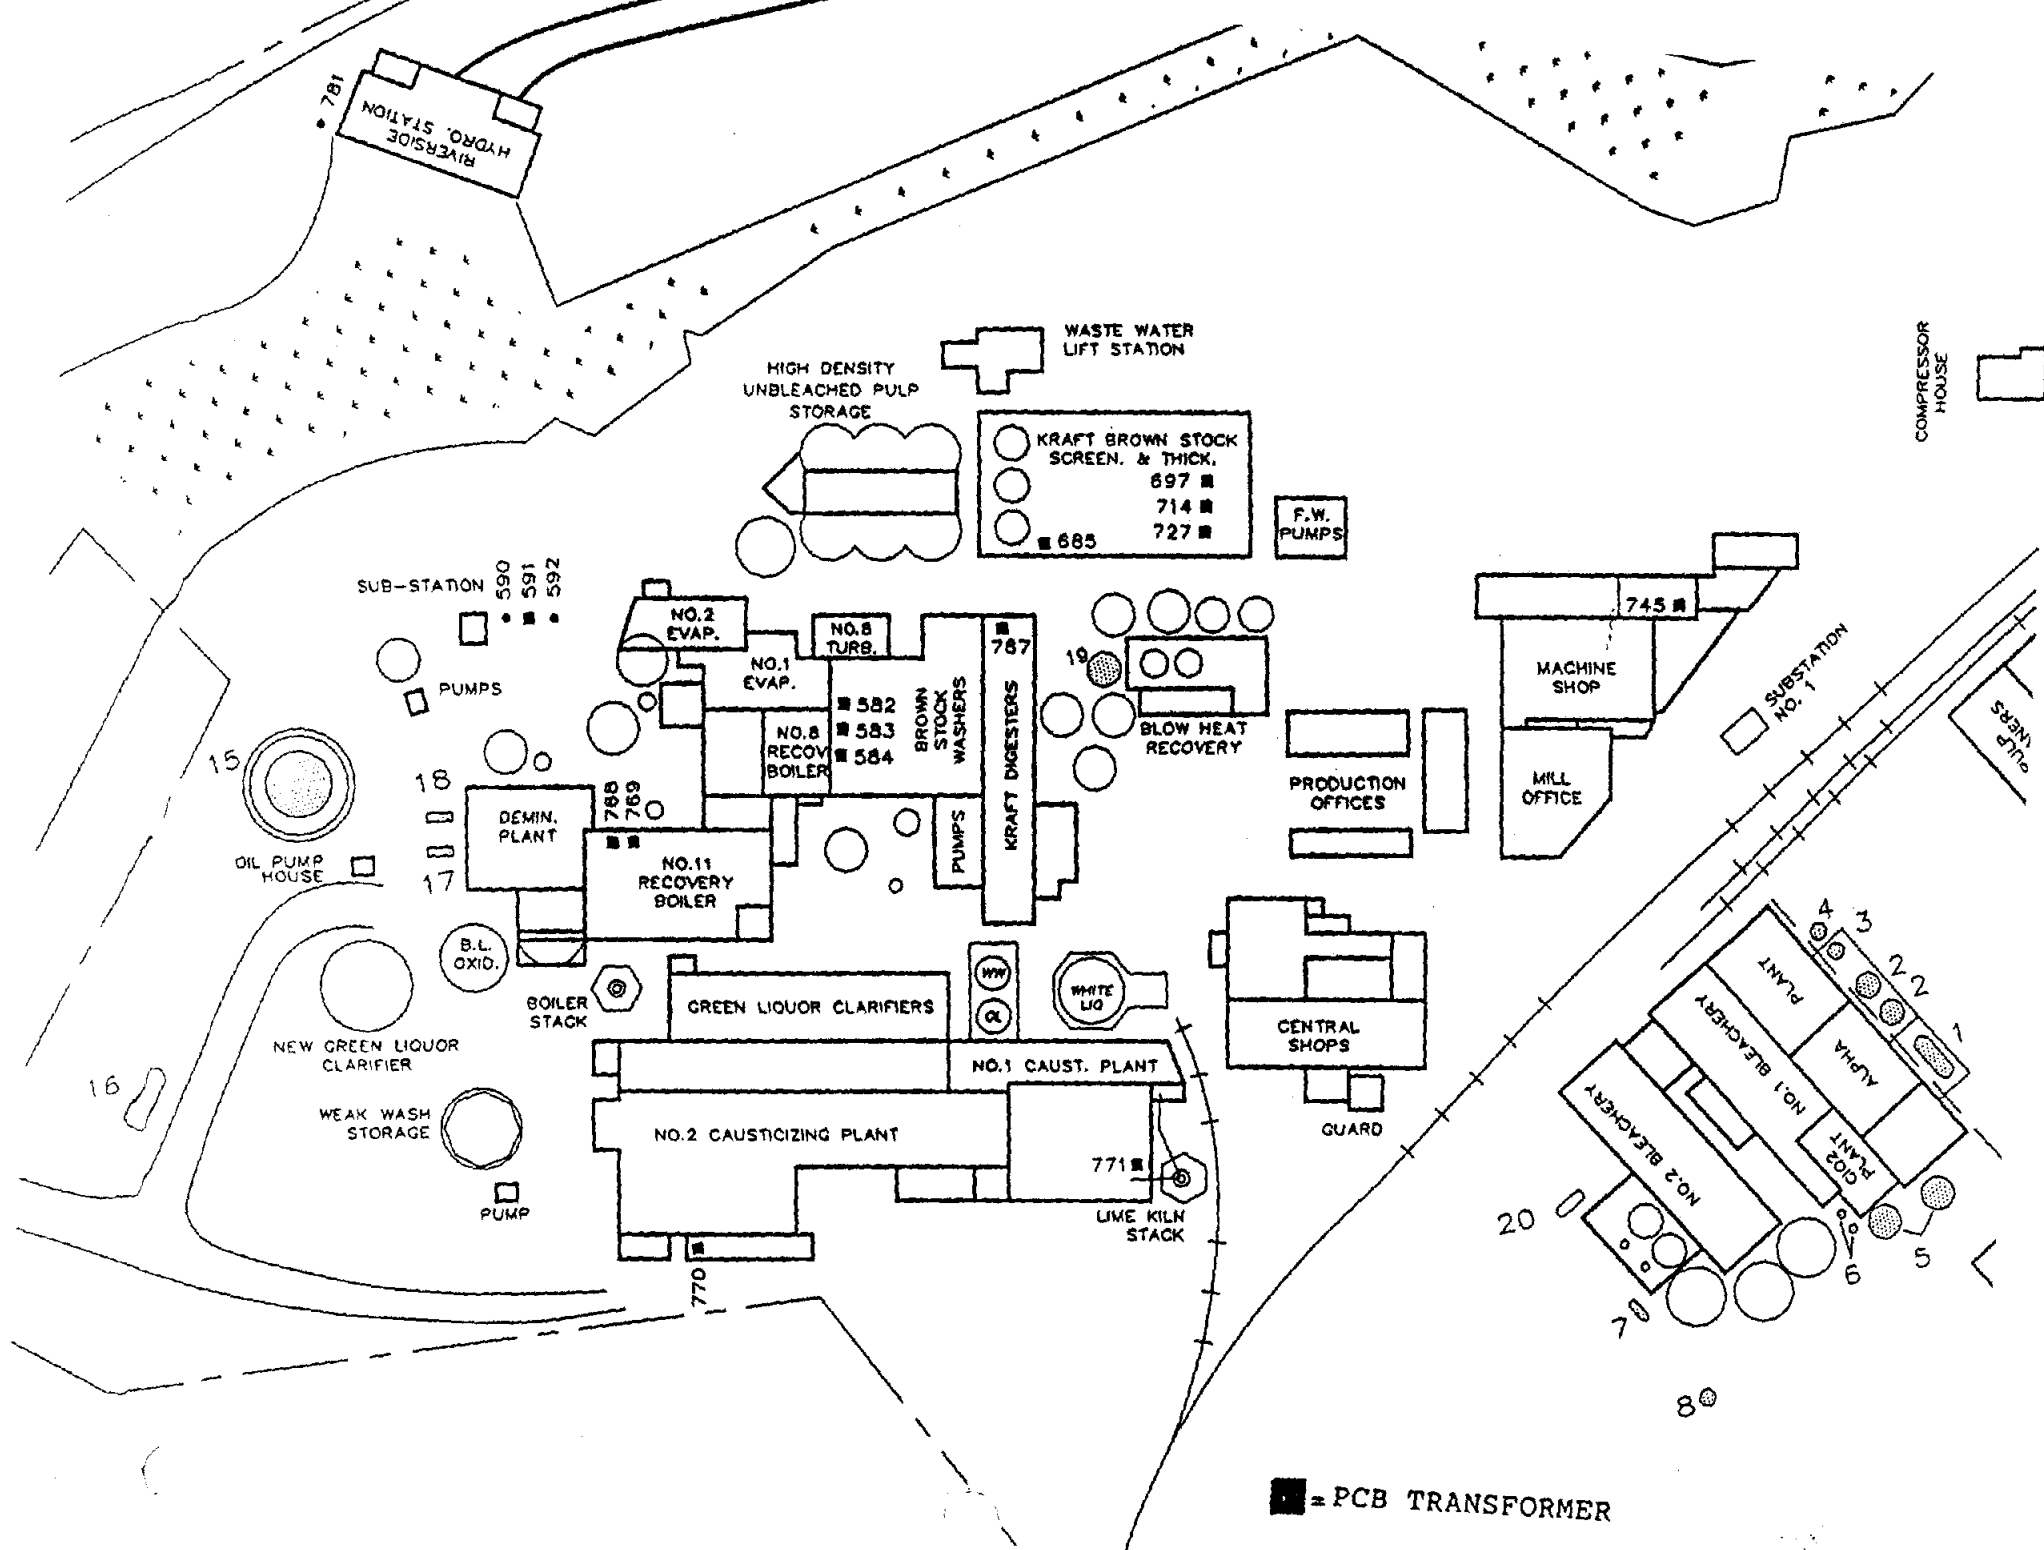
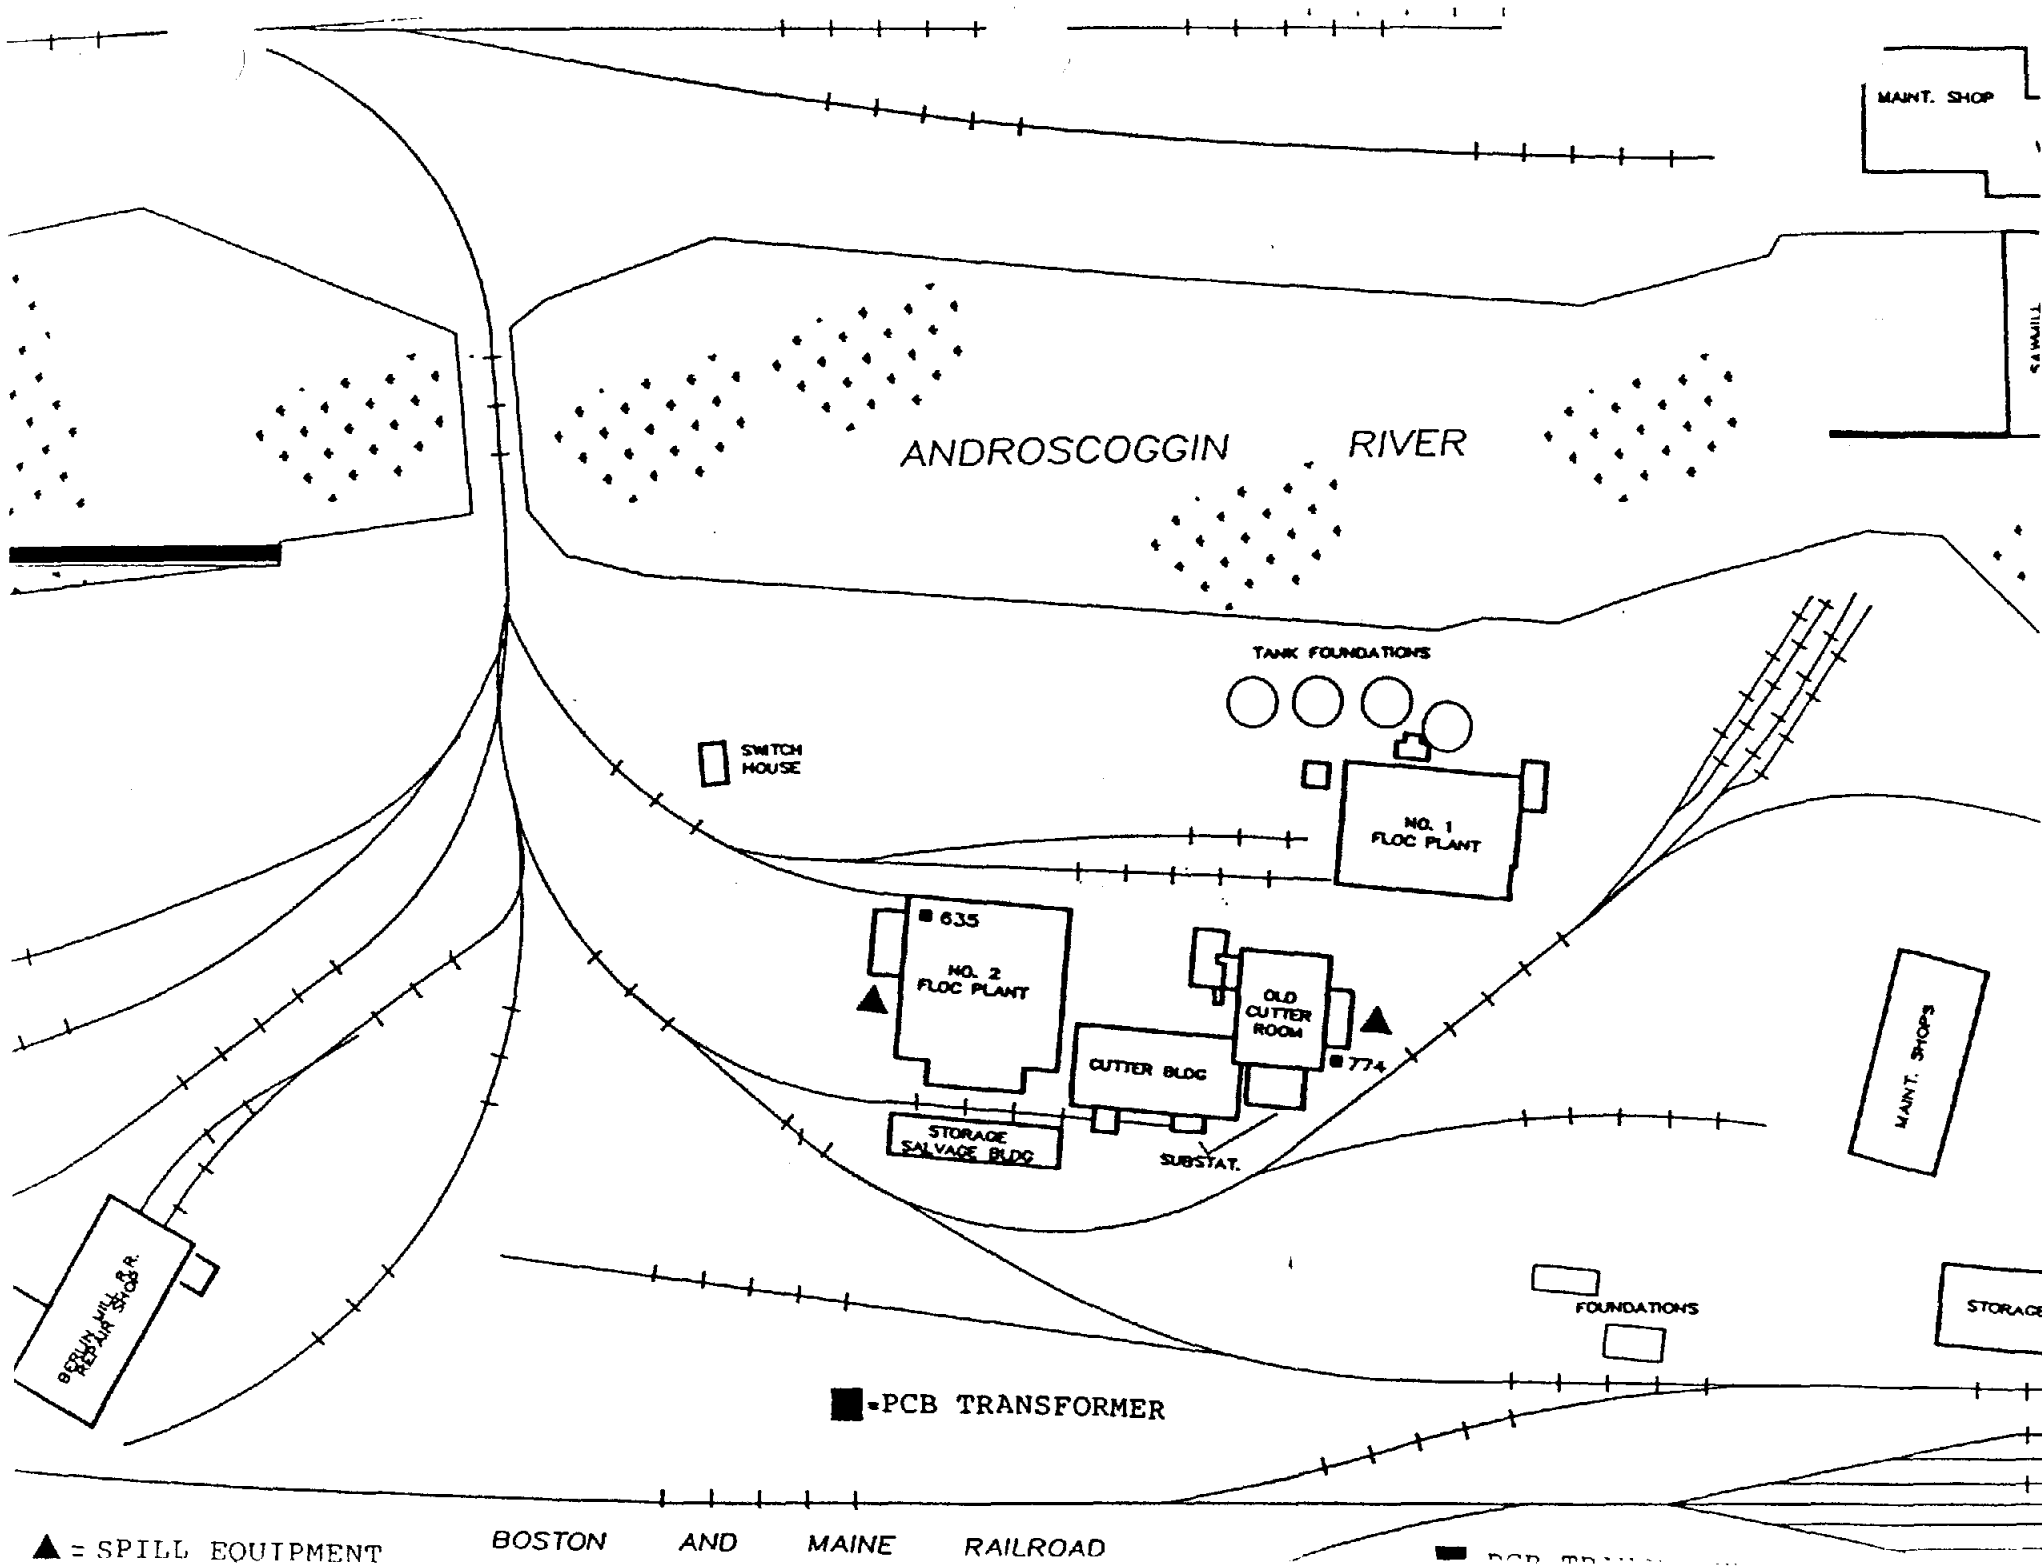
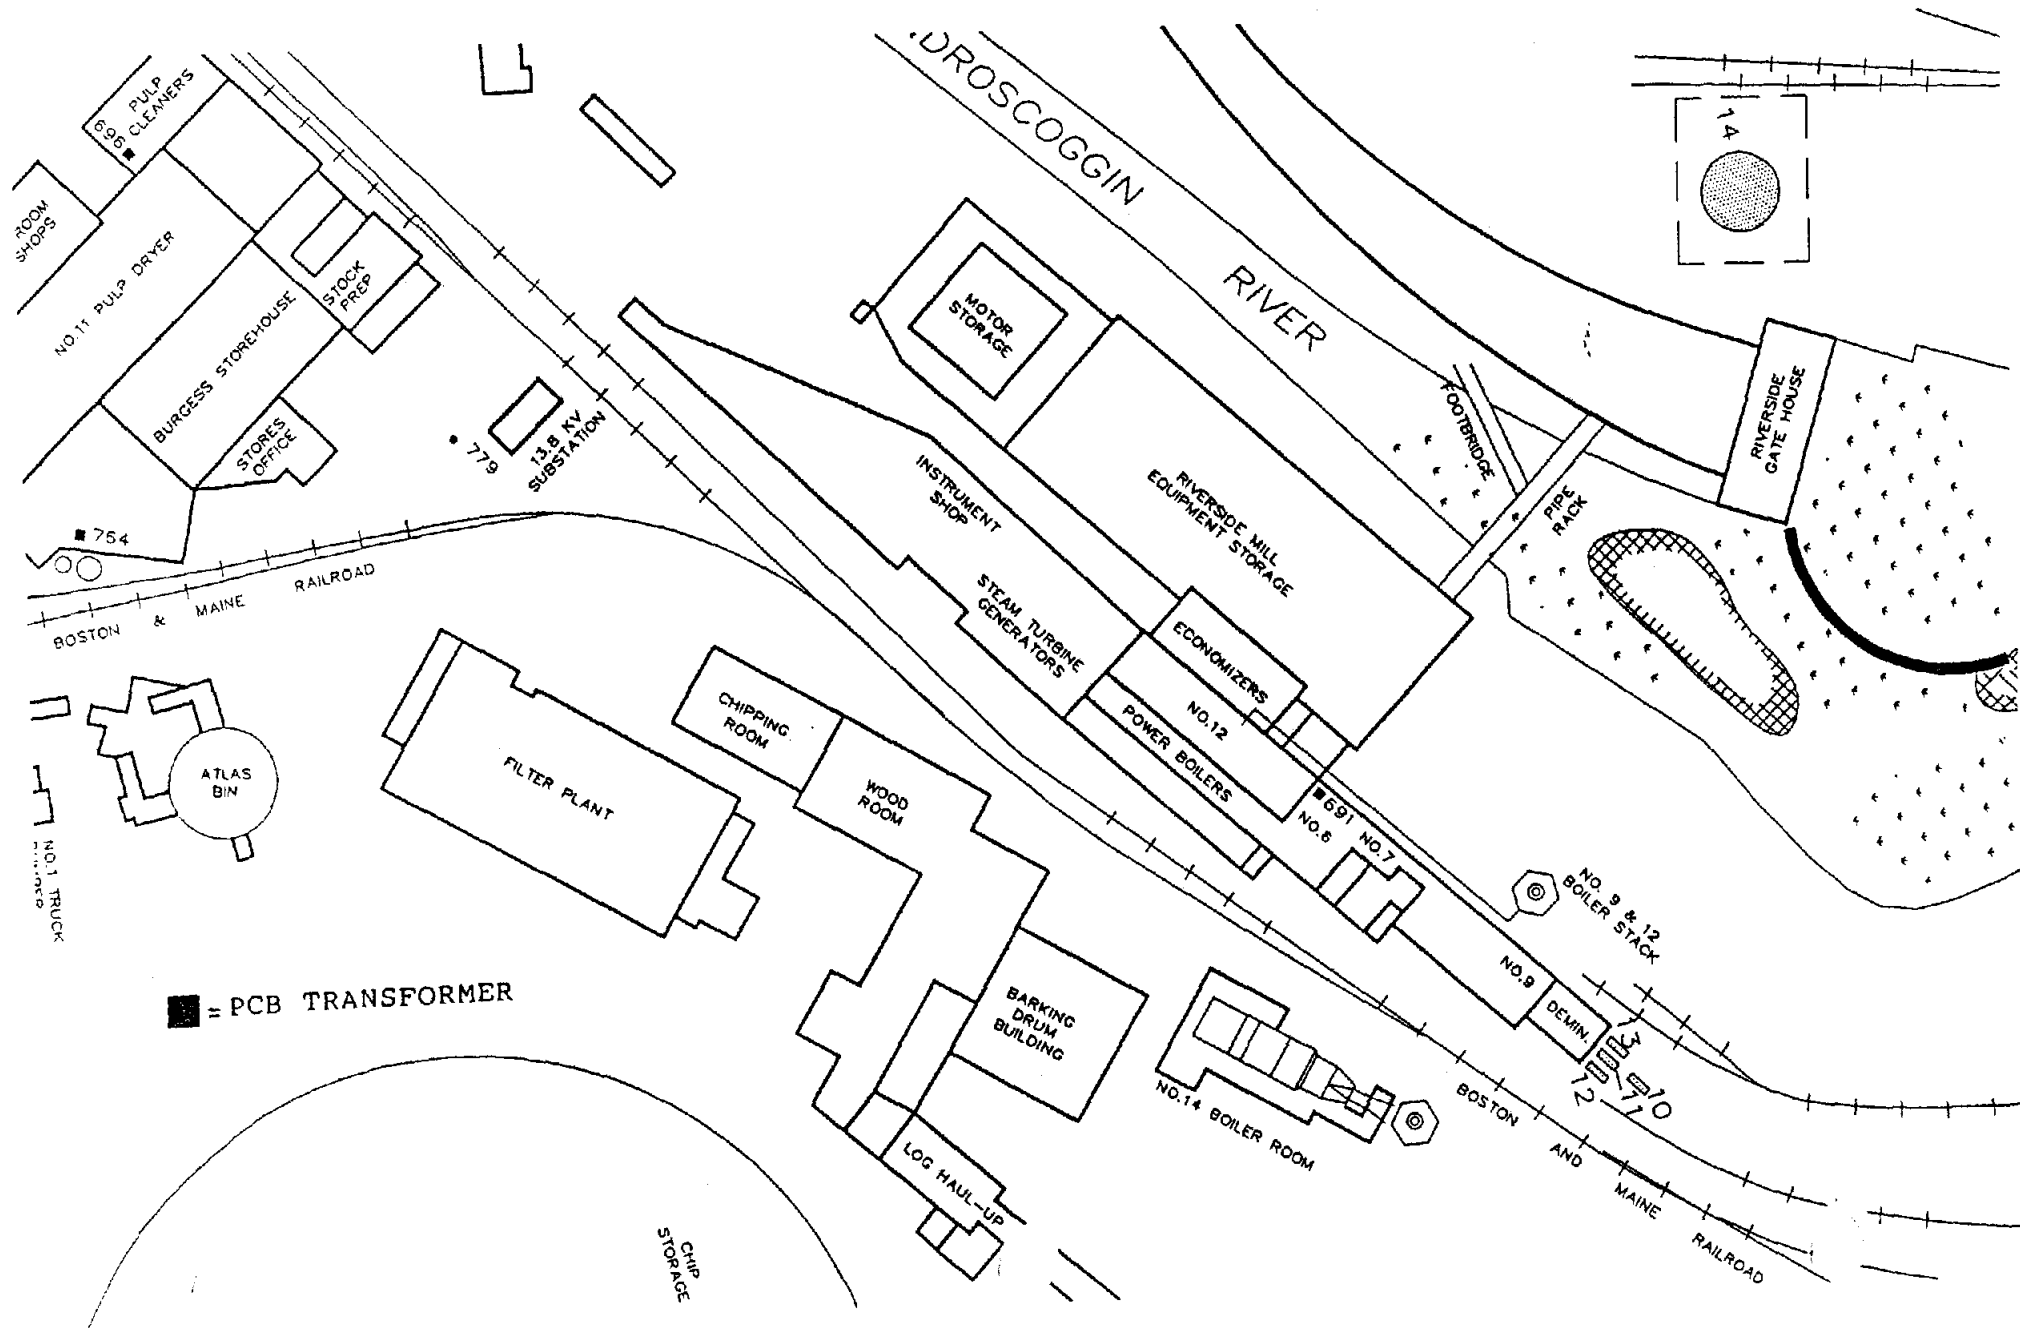
PCB Transformer Locations from the Gorham Fire Department

■ = PCB TRANSFORMER
